Uniform Mitigation Verification Inspection Form

Inspection Date: Mar 28, 2023		
Owner Information		
Owner Name: Errol By The Sea Club House		Contact Person:
Address: 4501 S Atlantic Ave		Home Phone:
City: New Smyrna	Zip: 32169	Work Phone:
County: Volusia		Cell Phone:
Insurance Company:		Policy #:
Year of Home: 1974	# of Stories: 1	Email:

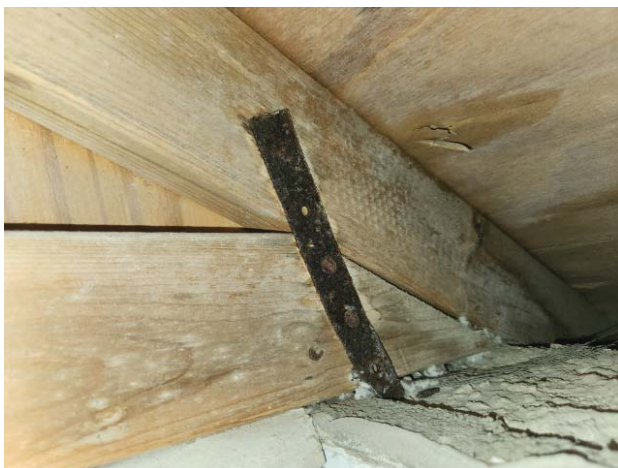
TRUSS CONNECTION

- ☒ Secured to truss/rafter with a minimum of three (3) nails, **and**
- ☒ Attached to the wall top plate of the wall framing, or embedded in the bond beam, with less than a ½" gap from the blocking or truss/rafter **and** blocked no more than 1.5" of the truss/rafter, **and** free of visible severe corrosion.
- ☒ B. Clips
 - ☒ Metal connectors that do not wrap over the top of the truss/rafter, **or**
 - ☐ Metal connectors with a minimum of 1 strap that wraps over the top of the truss/rafter and does not meet the nail position requirements of C or D, but is secured with a minimum of 3 nails.
- ☐ C. Single Wraps

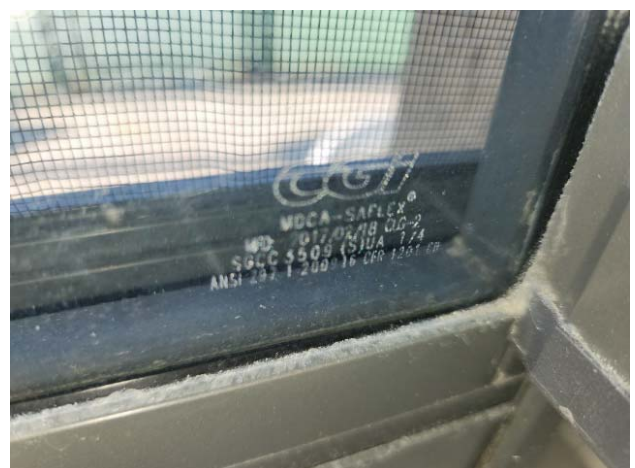
IMPACT GLASS

- ☒ **A. Exterior Openings Cyclic Pressure and 9-lb Large Missile (4.5 lb for skylights only)** All Glazed openings are protected at a minimum, with impact resistant coverings or products listed as wind borne debris protection devices in the product approval system of the State of Florida or Miami-Dade County and meet the requirements of one of the following for "Cyclic Pressure and Large Missile Impact" (Level A in the table above).

☒ A.1 All Non-Glazed openings classified as A in the table above, or no Non-Glazed openings exist

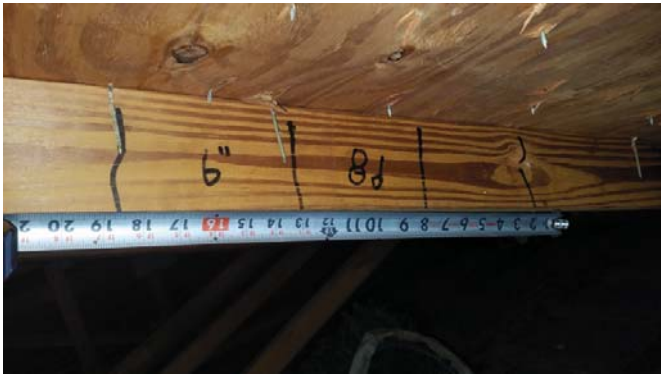
SPACING

- ☒ C. Plywood/OSB roof sheathing with a minimum thickness of 7/16" inch attached to the roof truss/rafter (spaced a maximum of 24" inches o.c.) by 8d common nails spaced a maximum of 6" inches in the field. -OR- Dimensional lumber/Tongue & Groove decking with a minimum of 2 nails per board (or 1 nail per board if each board is equal to or less than 6 inches in width). -OR-

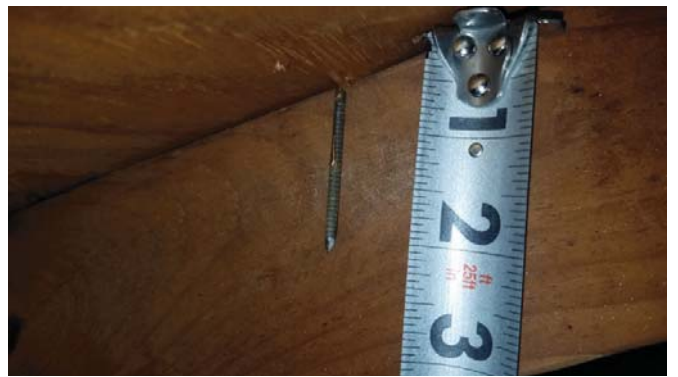
NAILS

Any system of screws, nails, adhesives, other deck fastening system or truss/rafter spacing that is shown to have an equivalent or greater resistance than 8d common nails spaced a maximum of 6 inches in the field or has a mean uplift resistance of at least 182 psf.
