# Uniform Mitigation Verification Inspection Form

Inspection Date: <b>Mar 28, 2023</b>		
<b>Owner Information</b>		
Owner Name: <b>Errol By The Sea Office/ Maintenance</b>		Contact Person:
Address: <b>4501 S Atlantic Ave</b>		Home Phone:
City: <b>New Smyrna</b>	Zip: <b>32169</b>	Work Phone:
County: <b>Volusia</b>		Cell Phone:
Insurance Company:		Policy #:
Year of Home: <b>1974</b>	# of Stories: <b>1</b>	Email:

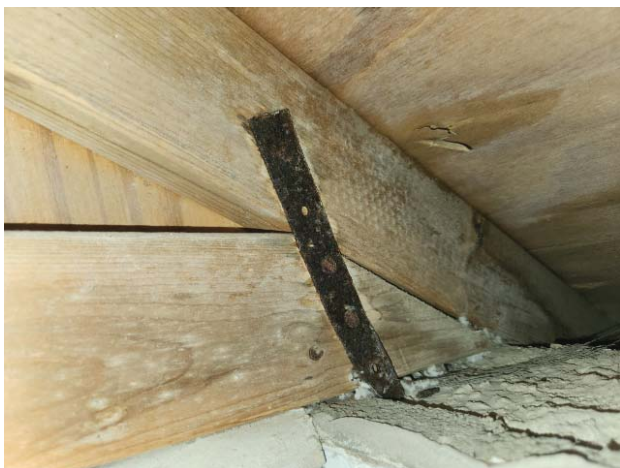
- ☒ B. Clips
  - ☒ Metal connectors that do not wrap over the top of the truss/rafter, **or**
  - ☐ Metal connectors with a minimum of 1 strap that wraps over the top of the truss/rafter and does not meet the nail position requirements of C or D, but is secured with a minimum of 3 nails.

TRUSS CONNECTION

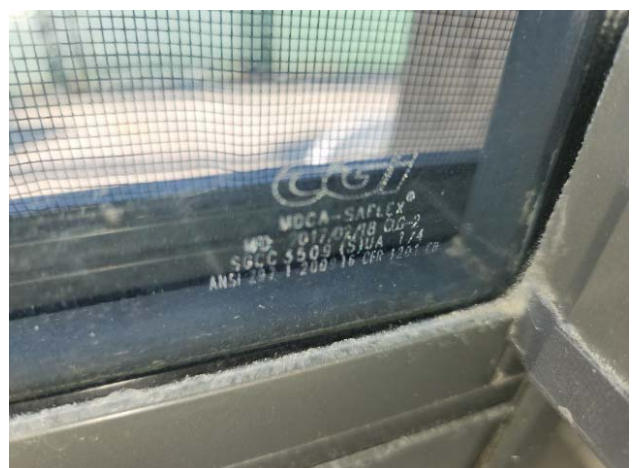
- ☒ **A. Exterior Openings Cyclic Pressure and 9-lb Large Missile (4.5 lb for skylights only)** All Glazed openings are protected at a minimum, with impact resistant coverings or products listed as wind borne debris protection devices in the product approval system of the State of Florida or Miami-Dade County and meet the requirements of one of the following for "Cyclic Pressure and Large Missile Impact" (Level A in the table above).

IMPACT GLASS

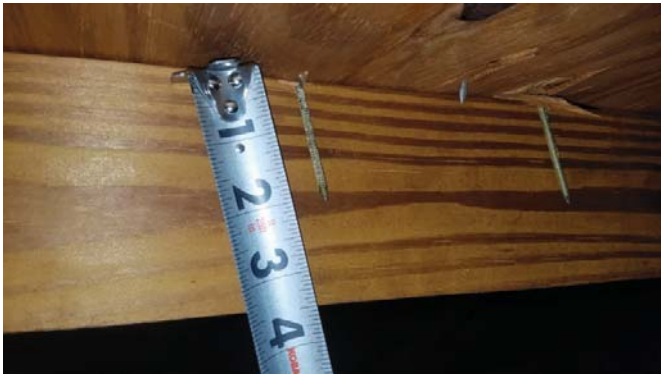
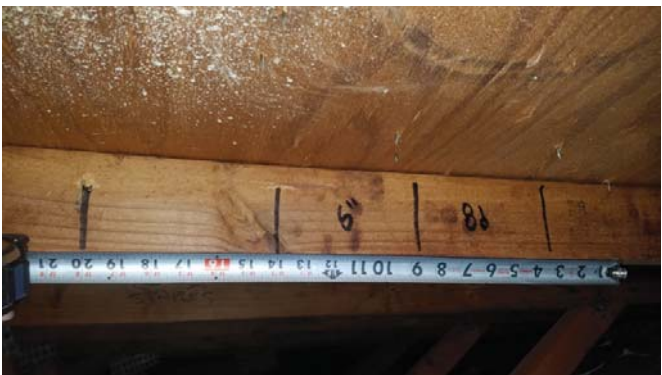
- ☒ C. Plywood/OSB roof sheathing with a minimum thickness of 7/16" inch attached to the roof truss/rafter (spaced a maximum of 24" inches o.c.) by 8d common nails spaced a maximum of 6" inches in the field. -OR- Dimensional lumber/Tongue & Groove decking with a minimum of 2 nails per board (or 1 nail per board if each board is equal to or less than 6 inches in width). -OR-

SPACING
