Uniform Mitigation Verification Inspection Form

Inspection Date: Feb 28, 2023		
Owner Information		
Owner Name: Errol By The Sea		Contact Person:
Address: 4501S Atlantic Ave		Home Phone:
City: New Smyrna	Zip: 32169	Work Phone:
County: Volusia		Cell Phone:
Insurance Company:		Policy #:
Year of Home: 1974	# of Stories: 5	Email:

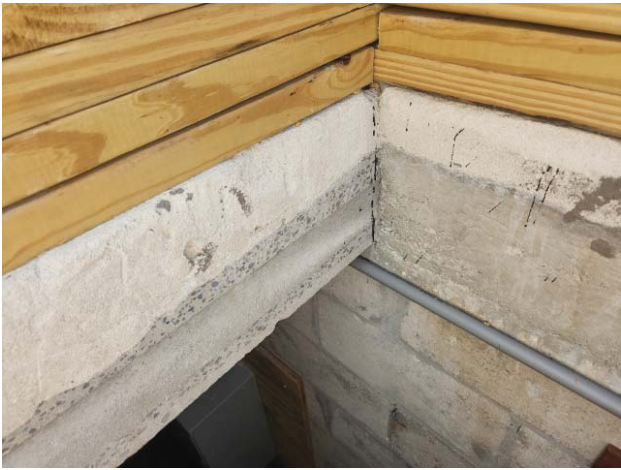
- ☒ D. Reinforced Concrete Roof Deck.
- ☐ E. Other: _____
- ☐ F. Unknown or unidentified.
- ☐ G. No attic access.

CONCRETE ROOF FDECK
